# AMBIENT MONITORING REPORT STATE 30-16 PAD KERR-MCGEE OIL & GAS ONSHORE LP

Document Number: **017AA-011278-RT-74**

Reporting Period: October 10 through October 17, 2021

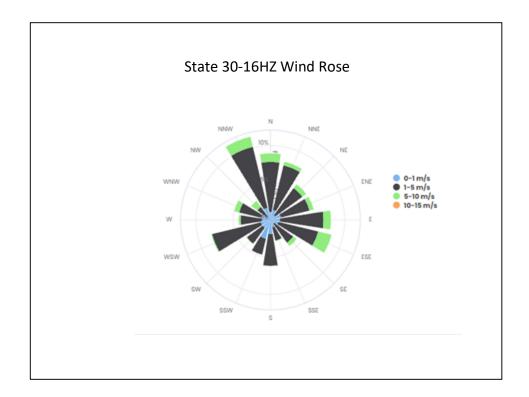
Figure 2 – State 30-16HZ Meteorological Data

The wind rose below is shown for State 30-16HZ facility and is plotted with 15-minute averages.

Meteorological data, collected on the PID analyzer onsite, for the reporting period can be found in the Figure 2.
