**AMBIENT MONITORING REPORT  
STATE 30-16 PAD  
KERR-MCGEE OIL & GAS ONSHORE LP**

Document Number: **017AA-011278-RT-70**  
Reporting Period: **October 3 through October 10, 2021**  
Report Date: **October 11, 2021**

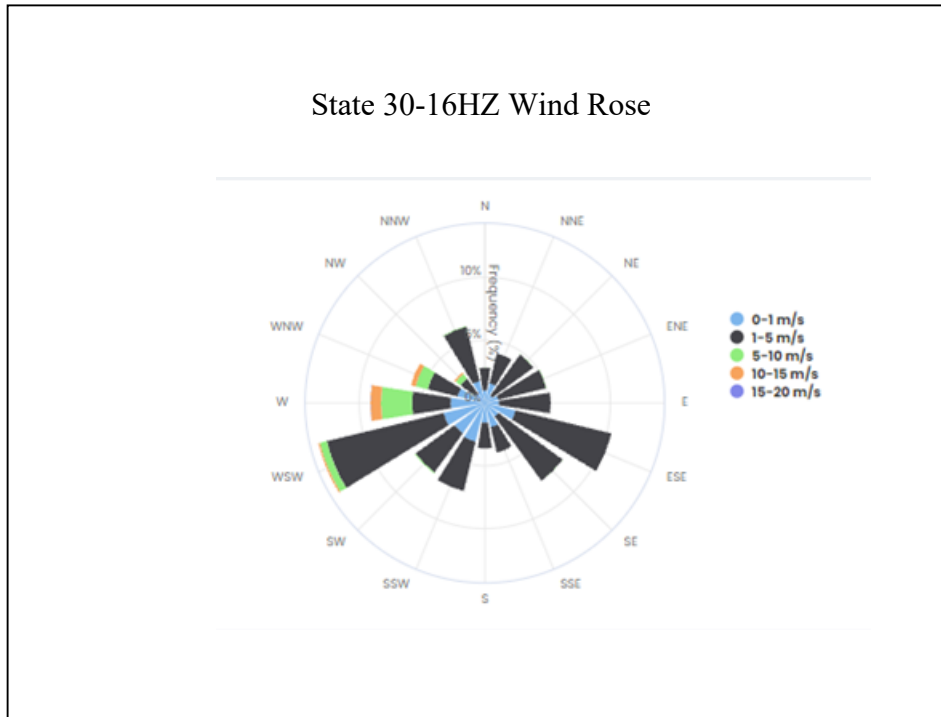
**Figure 2 – State 30-16HZ Meteorological Data**

The wind rose below is shown for State 30-16HZ facility and is plotted with 15-minute averages.

Meteorological data, collected on the PID analyzer onsite, for the reporting period can be found in the Figure 2.
