**AMBIENT MONITORING REPORT
STATE 30-16 PAD
KERR-MCGEE OIL & GAS ONSHORE LP**

| Document Number: | 085AA-011280-RT-382 |
| Reporting Period: | April 4 through April 10, 2023 |

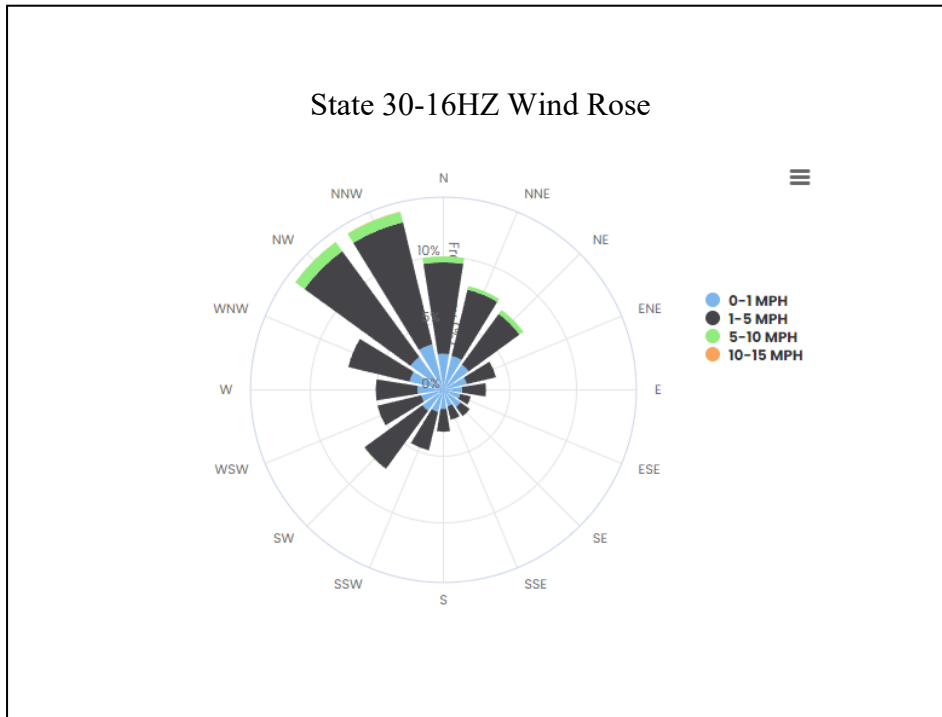
Figure 2 – State 30-16HZ Meteorological Data

The wind rose below is shown for State 30-16HZ facility and is plotted with 15-minute averages.

Meteorological data, collected on the PID analyzer onsite, for the reporting period can be found in the Figure 2.
