**AMBIENT MONITORING REPORT
STATE 30-16 PAD
KERR-MCGEE OIL & GAS ONSHORE LP**

Document Number: **017AA-011278-RT-56**
Reporting Period: **September 10 through September 19, 2021**
Report Date: **September 22, 2021**

Montrose Air Quality Services, LLC (Montrose) was contracted by Kerr-McGee Oil & Gas Onshore LP (Kerr-McGee) to conduct air monitoring at the State 30-16HZ Pad. This report covers the reporting period from September 10 through September 19, 2021. Facility monitoring commenced on September 10, 2021. Air Monitoring was conducted in accordance with applicable portions of the Kerr-McGee Air Monitoring Program that has been approved by Colorado Department Public Health and Environment (CDPHE). There were no readings from the continuous PID analyzers above the Investigation Levels.

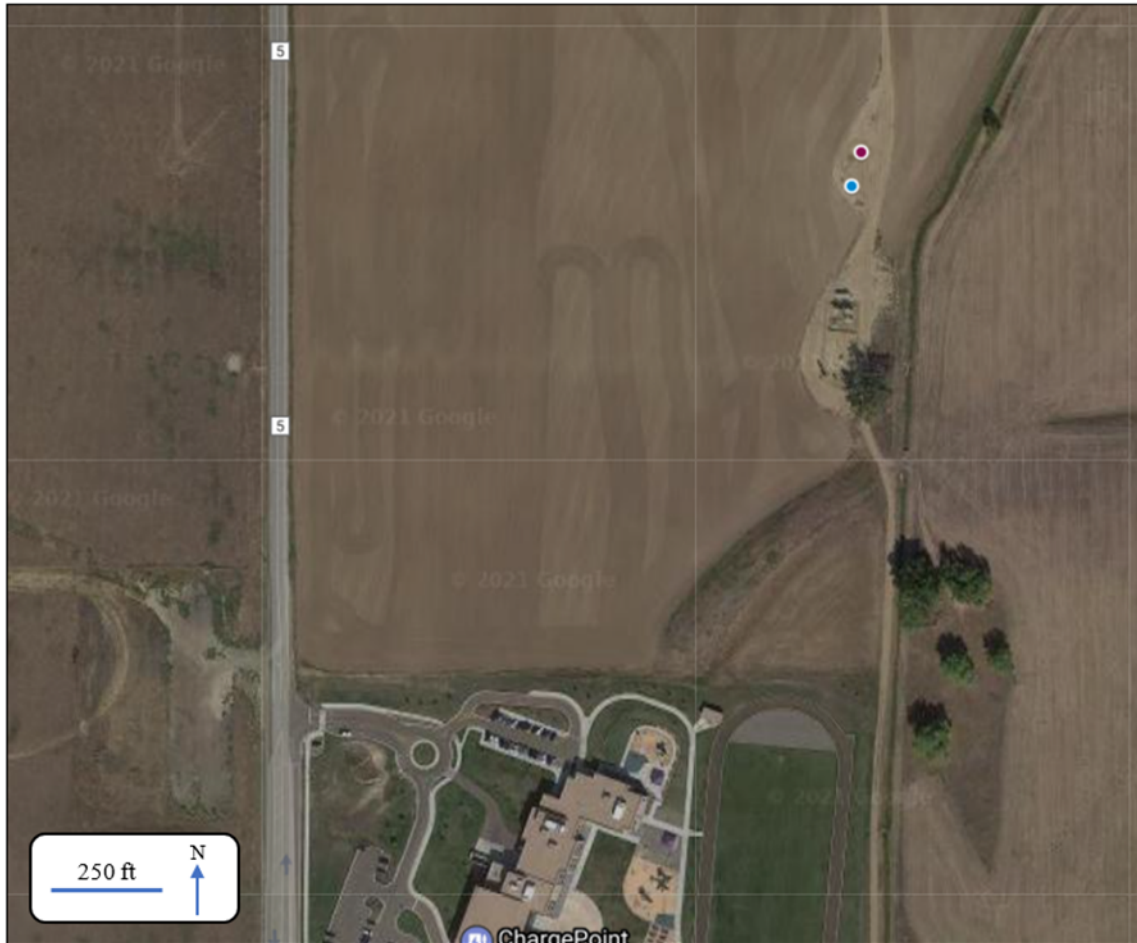
Sampling locations are labeled by ID on the map below.

Location Tag	Description
 	State Pad Monitoring Wells
 	PID Analyzer

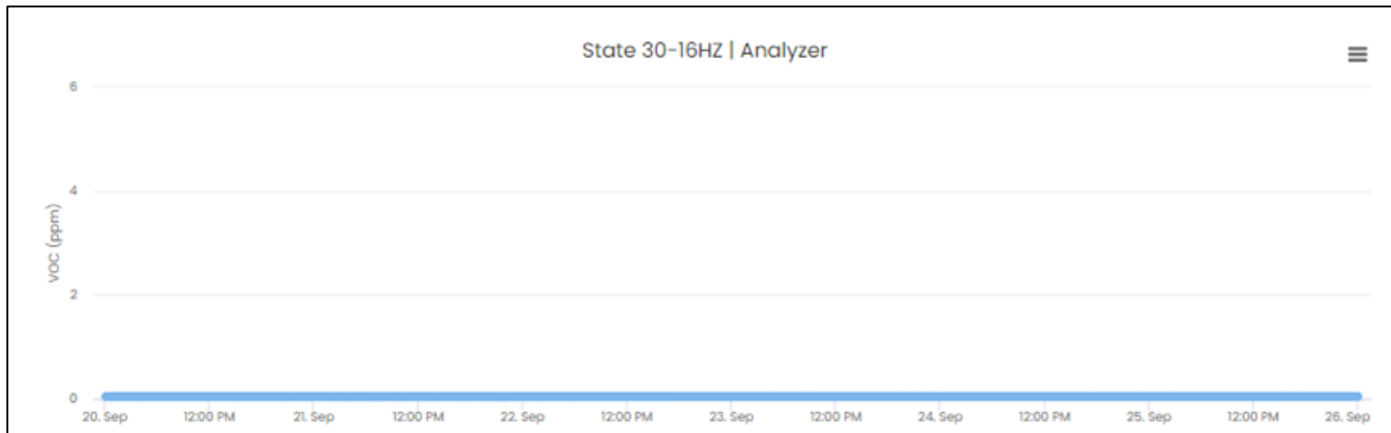
Figure 1 – State 30-16HZ VOC Data

The 15-minute block averages for the PID VOC results for the air sampling can be found in Figure 1.

The graph below is shown for the PID Analyzer installed at the State 30-16HZ facility during and is plotted with 15-minute averages.

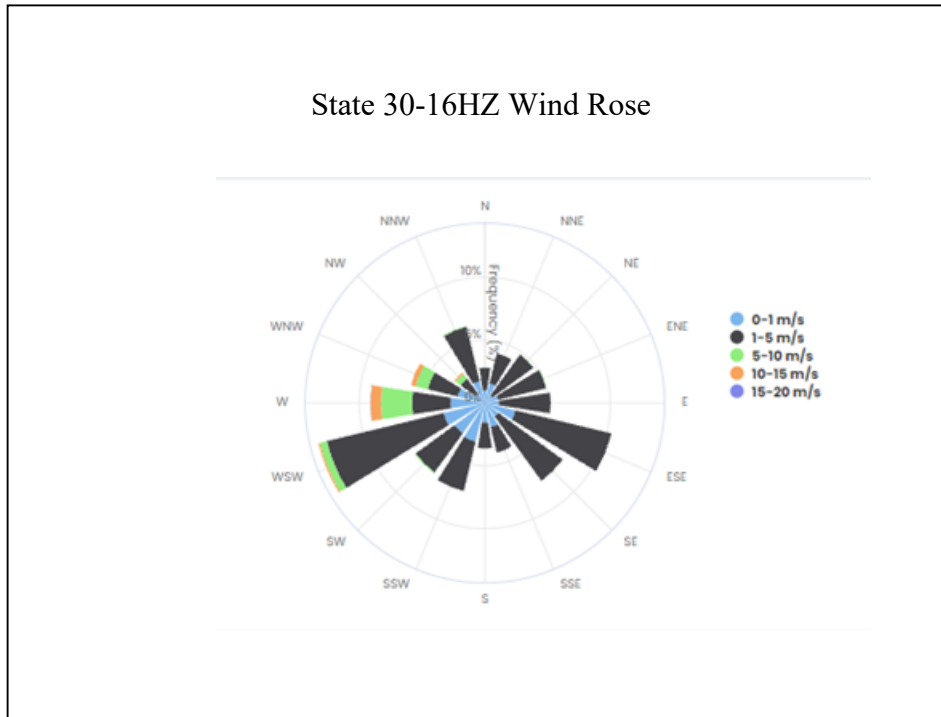
Figure 2 – State 30-16HZ Meteorological Data

Meteorological data, collected on the PID analyzer onsite, for the reporting period can be found in the Figure 2.

The wind rose below is shown for State 30-16HZ facility and is plotted with 15-minute averages.

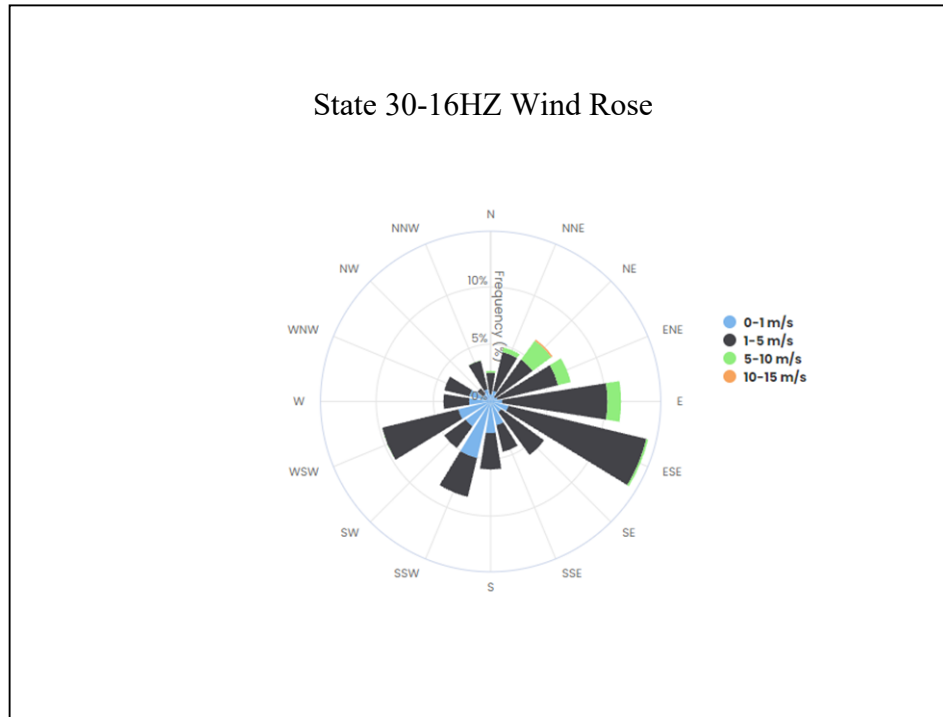
Figure 2 – State 30-16HZ Meteorological Data

Meteorological data, collected on the PID analyzer onsite, for the reporting period can be found in the Figure 2.

The wind rose below is shown for State 30-16HZ facility and is plotted with 15-minute averages.

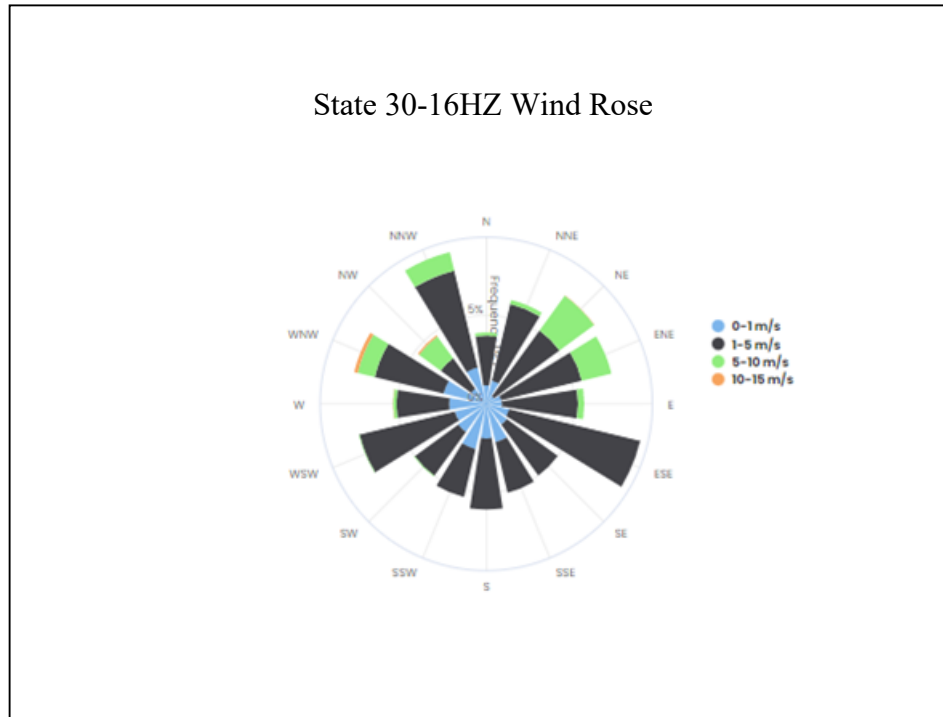
Figure 2 – State 30-16HZ Meteorological Data

Meteorological data, collected on the PID analyzer onsite, for the reporting period can be found in the Figure 2.

The wind rose below is shown for State 30-16HZ facility and is plotted with 15-minute averages.

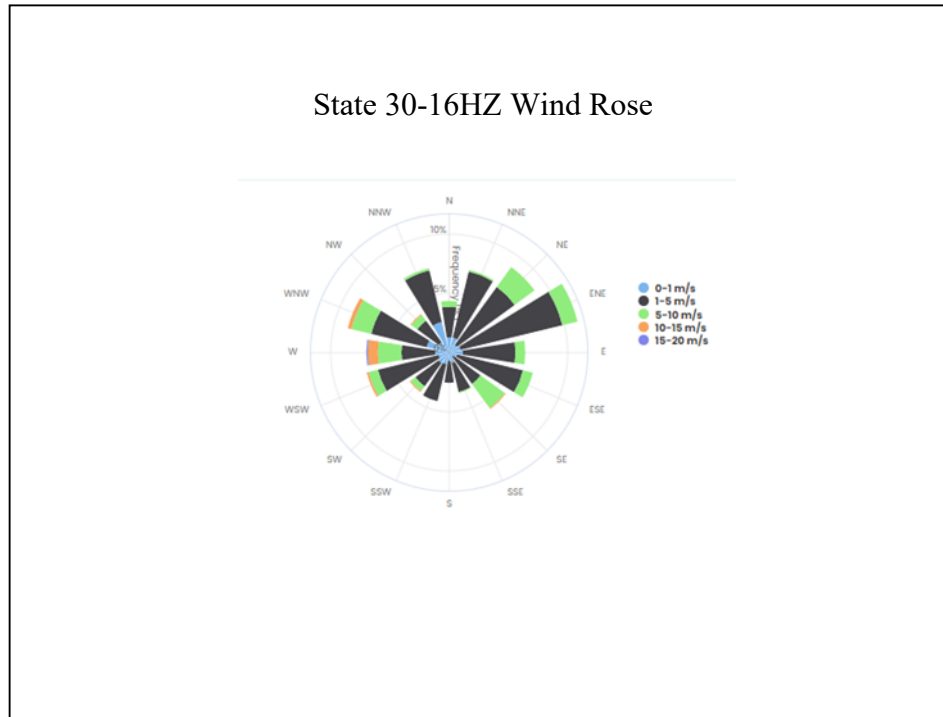
Figure 2 – State 30-16HZ Meteorological Data

Meteorological data, collected on the PID analyzer onsite, for the reporting period can be found in the Figure 2.

The wind rose below is shown for State 30-16HZ facility and is plotted with 15-minute averages.
